American Home Inspections of NE NC

Page 1 of 23
Unit #46010A

Property Address US Coast Guard Housing, Unit #46010A Kinnakeet Rd

Client Name U S Coast Guard

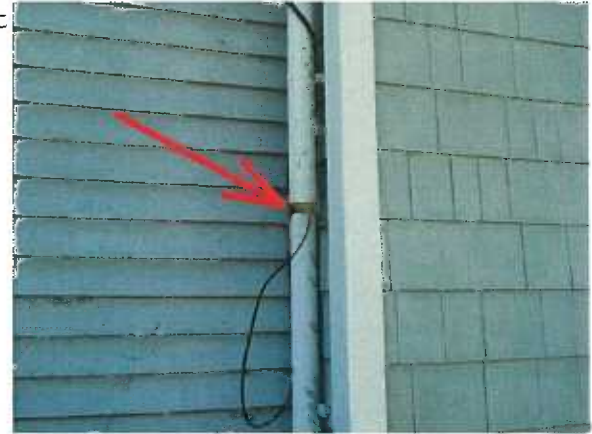
11. ☐ ☐ ☐ ☐ ☒ Downspouts: Plastic The gutter down spout has become disconnected.

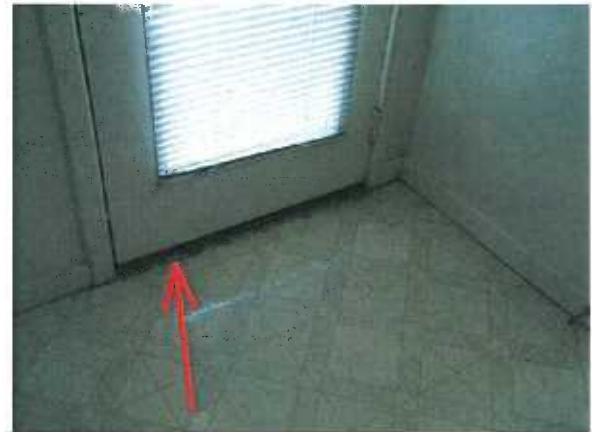
1. **Exterior Walls Exterior Surface Type:** Horizontal Wood Ship Lap Siding All exterior wall surfaces should be examined and re nailed in the areas where is has become loose. The exterior of the house should be pressure washed and repainted.
2. **Accent Walls Exterior Surface Type:** Plywood Panels with machine shake appearance. The machine shake look plywood panels, the nails are loose in several places. The exterior walls should be examined and the loose siding re nailed. The exterior of the house should be pressure washed and repainted.
3. **Entry Door:** Kitchen/Dining Area, Fiberglass, Full View Glass Moisture is migrating to the inside at the door threshold. The door and threshold need to be adjusted to stop the moisture migration.

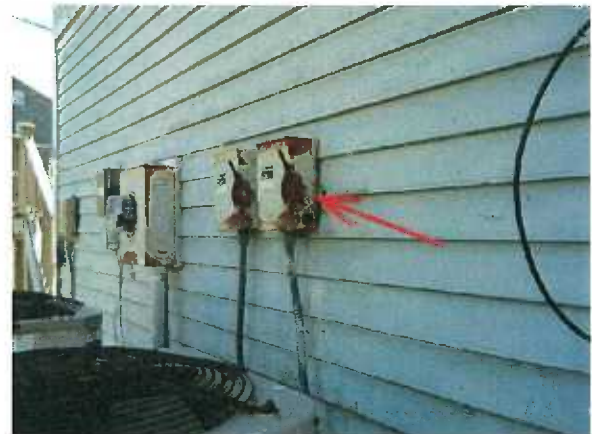
5. **North Side AC System Electrical Disconnect:** Tumble switch The HVAC electric disconnect box is very rusty.
6. **North Side AC System Electrical Disconnect:** Tumble switch The HVAC electric disconnect box is very rusty.

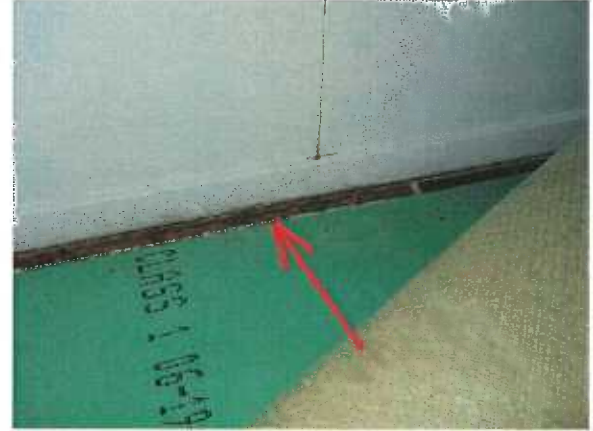
10. Rear Right Bedroom Closet: Single The closet door needs to be adjusted to fit into the opening properly.
11. Rear Right Bedroom Floor: Carpet The carpet tack strip along the unit party wall, the strip is stained and the tacks are rusty.

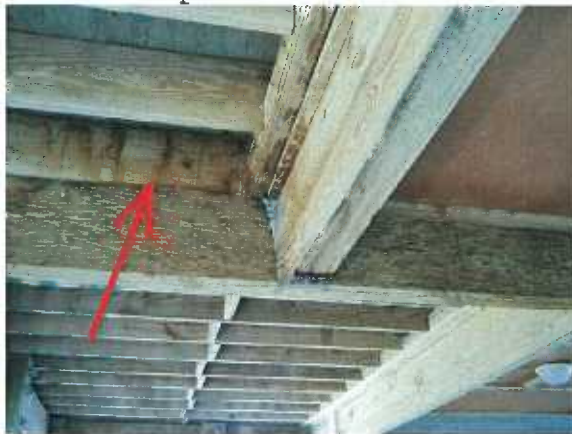
1. **Deck: Front, Pressure Treated Wood** The front deck handrails and wood pickets are deteriorated and should be replaced. One of the deck floor joist is not properly installed with a ledger or metal joist hanger. From under the deck, the floor joist below the party wall above, the floor joist are stained. This indicates that moisture is migrating from the roof through the party wall and exiting under the house in the carport.

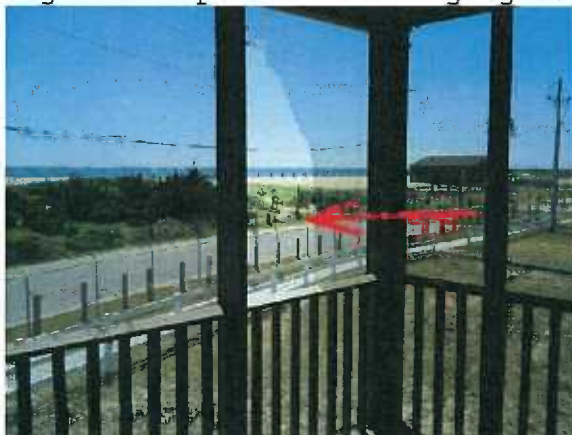
2. **Porch: Rear Porch, Pressure Treated Wood** Screen panels for the porch are missing or damaged. The porch screen door is damaged. There is one place where the ceiling soffit panels are bulging down ward.

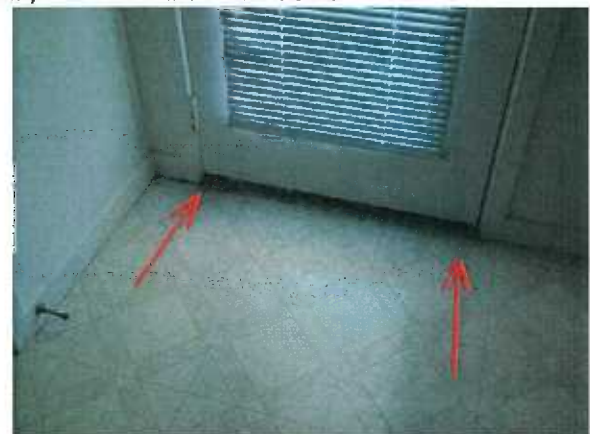
15. ☐ ☐ ☐ ☐ ☒ Entry Door: Kitchen/Dining Area, Fiberglass, Full view Glass Moisture is migrating to the inside at the door threshold. The door and threshold

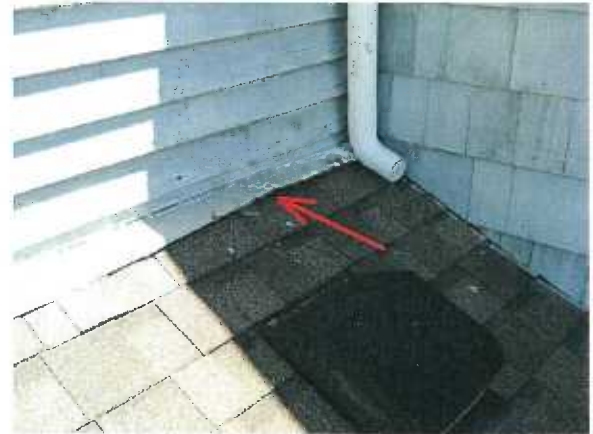
5. ☐ ☐ ☐ ☒ ☐ Flashing: Metal The flashing at the rear wall is not properly installed.

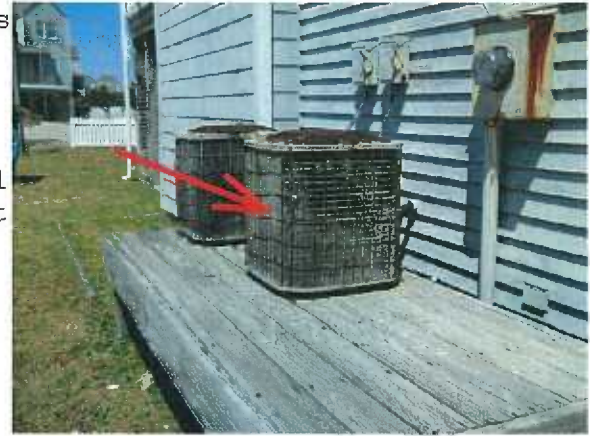
18. ☐ ☐ ☐ ☐ ☒ **Visible Coil:** Copper core with aluminum fins
The aluminum fins surrounding the copper coil are becoming deteriorated and falling away from the copper coil. The aluminum fins are present to dissipate the heat from the copper coil and when the fins are no longer present the coil will over heat and the condenser will cease to function.

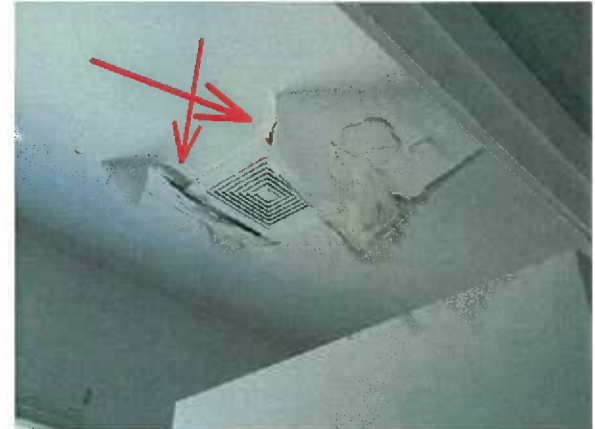
1. ☐ ☐ ☐ ☐ ☒ Ceiling: Drywall There is a large hole in the drywall ceiling.

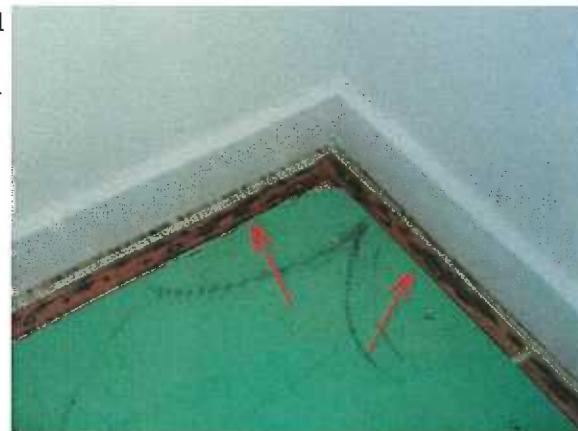
9. ☐ ☐ ☐ ☒ ☐ Closet: Single The closet door needs to be adjusted to fit into opening properly.
10. ☒ ☐ ☐ ☐ ☐ Ceiling: Drywall
11. ☒ ☐ ☐ ☐ ☐ Walls: Drywall
12. ☒ ☐ ☐ ☐ ☐ Floor: Carpet
13. ☒ ☐ ☐ ☐ ☐ Doors: Painted, Flush Solid Core
14. ☐ ☐ ☐ ☒ ☐ Windows: Andersen, Double Hung, Tilt and Wash There are moisture stains on the carpet tack strip along the party wall.

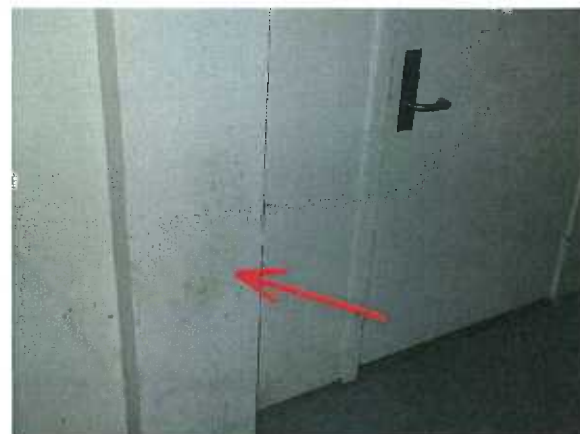
1. ☒ ☐ ☐ ☐ ☐ Ceiling: Drywall
2. ☐ ☐ ☐ ☒ ☐ Walls: Paneling, Painted There is presence of organic growth on the painted plywood walls of this room.

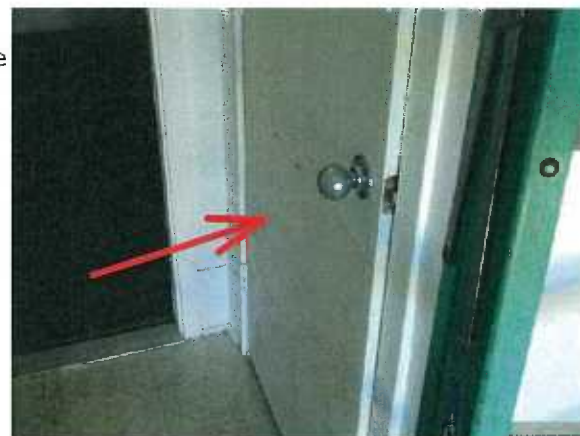
15. ☐ ☐ ☐ ☒ ☐ Closet: Single The closet door needs to be adjusted to fit into the opening properly.
16. ☒ ☐ ☐ ☐ ☐ Ceiling: Drywall
17. ☒ ☐ ☐ ☐ ☐ Walls: Drywall
18. ☒ ☐ ☐ ☐ ☐ Floor: Vinyl floor covering
19. ☐ ☐ ☐ ☒ ☐ Doors: Painted, Flush Solid Core There is organic growth on the surface of the door.

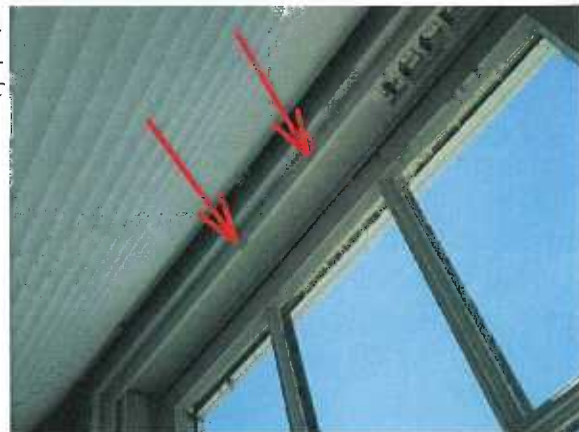
| 25. | <input type="checkbox"/> | <input type="checkbox"/> | <input type="checkbox"/> | <input checked="" type="checkbox"/> | <input type="checkbox"/> | Windows: Andersen, Double Hung, Tilt and Wash There are drip stains on the vinyl header piece of the window on the outer wall. |

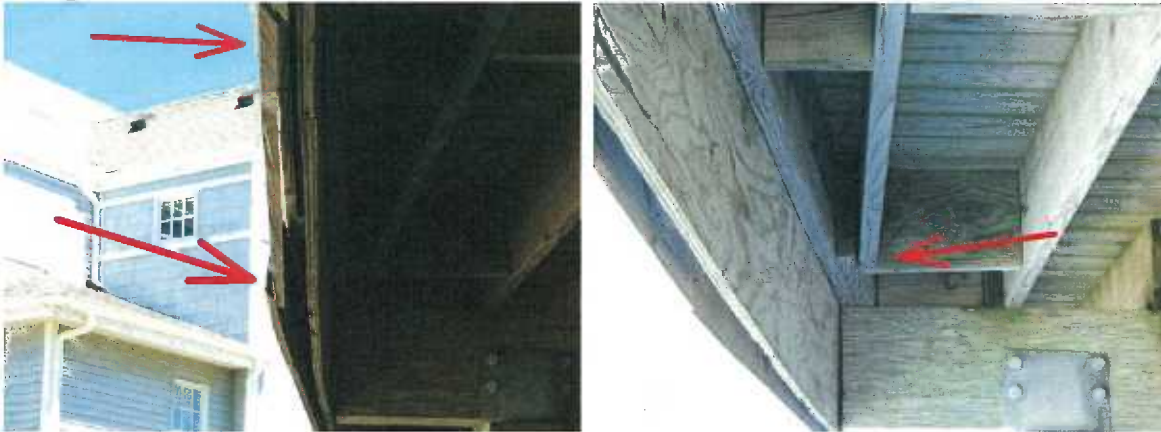
1. **Deck: Front, Pressure Treated Wood** The front lower trim boards are loose and need to be re nailed.
One of the deck floor joist is not properly supported with a ledger or metal joist hanger.

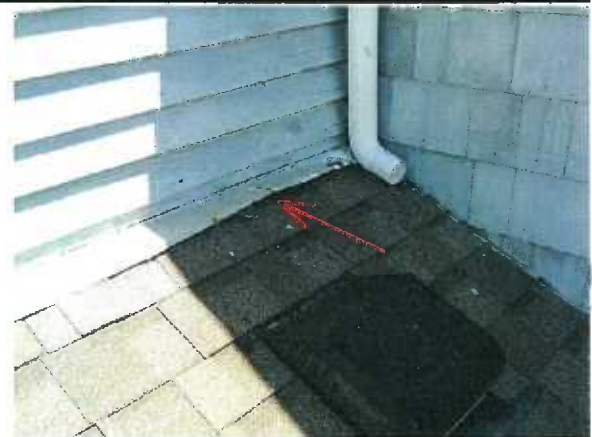
3. **Flashing: Metal** The flashing at the rear wall is not properly installed.

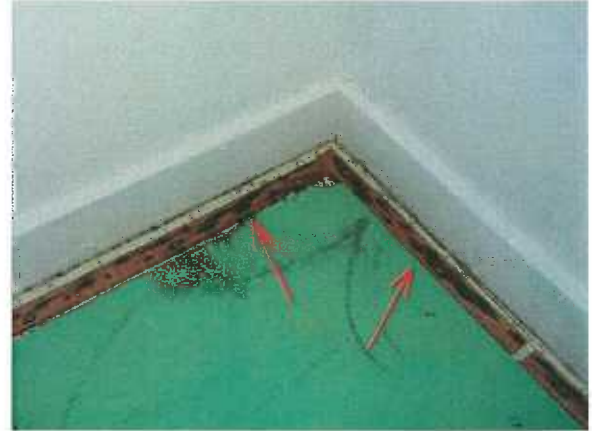
7. Rear Right Bedroom Closet: Single The closet door needs to be adjusted to fit into opening properly.
8. Rear Right Bedroom Windows: Andersen, Double Hung, Tilt and Wash There are moisture stains on the carpet tack strip along the party wall.

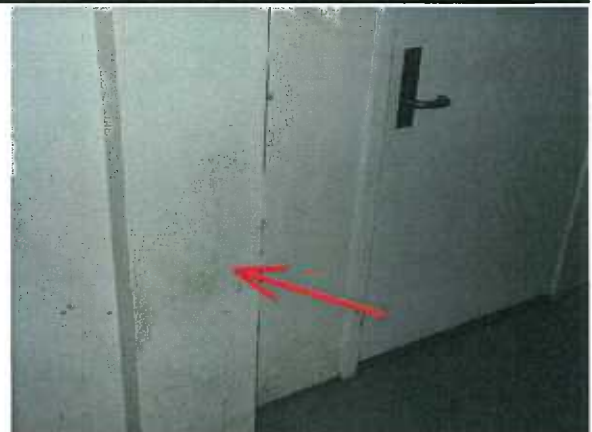
10. Ground Level Utility/Storage Room Living Space Walls: Paneling, Painted There is presence of organic growth on the painted plywood walls of this room.

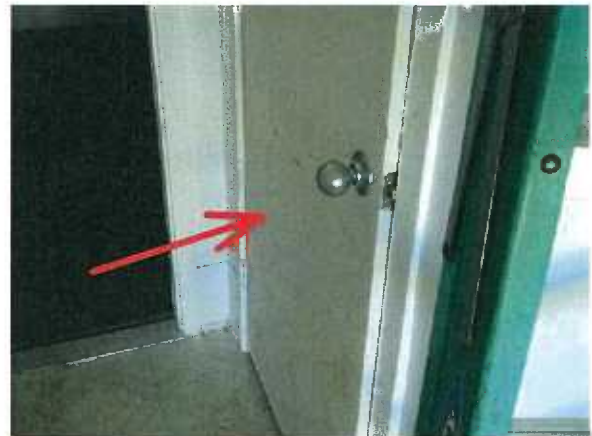
11. Ground Level Entry Living Space Closet: Single The closet door needs to be adjusted to fit into the opening properly.
12. Ground Level Entry Living Space Doors: Painted, Flush Solid Core There is organic growth on the surface of the door.

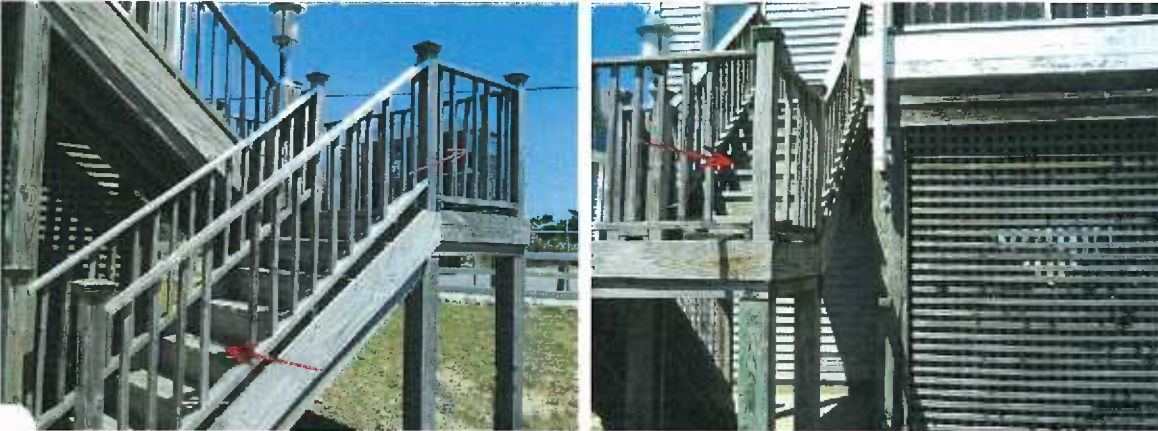
1. **Porch:** Rear Porch, Pressure Treated Wood Screen panels for the porch are missing or damaged. The porch screen door is damaged.
2. **Stairs/Landing:** Rear Stairs & Landing, Pressure Treated Wood The wood pickets are loose or out of place. The nails used to secure the pickets are rusty/deteriorated. The wood trim skit boards are loose and need to be re nailed.

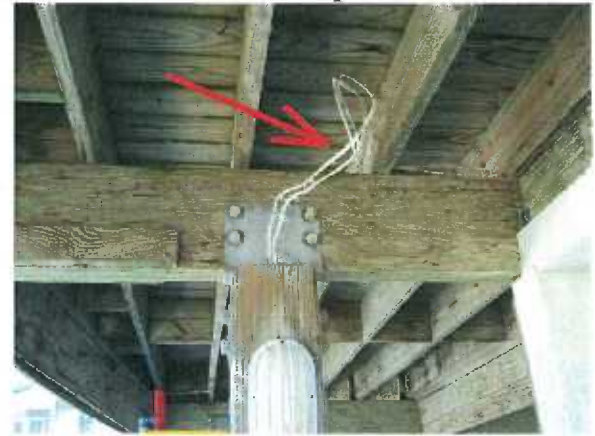
5. Entry Door: Kitchen/Dining Area, Fiberglass, Full view Glass Moisture is migrating to the inside at the door threshold. The door and threshold need to be adjusted to stop the moisture migration.
6. Window Screens: Metal wire There are several screens at various location in the house that are not installed in the windows. No effort was made to inventory the windows.
7. Exterior Lighting: Exterior, Surface Mount There is a exterior light under the front deck that was wired with interior romex wiring that should have been installed in electrical conduit. There is a light installed for the rear stairs. The interior romex wiring for this light should have been installed in electrical conduit.

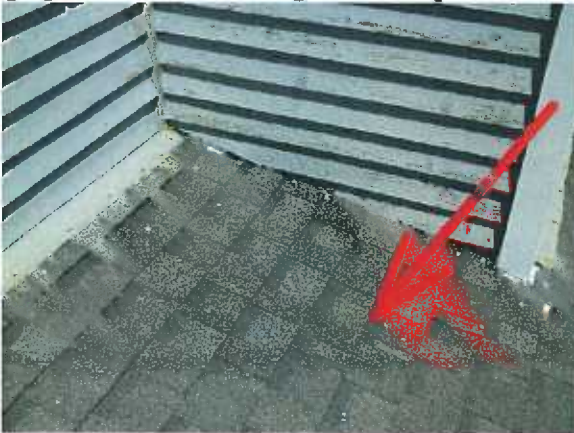
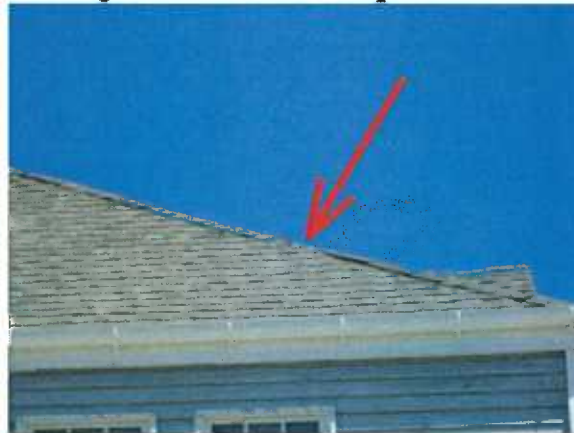
8. All Roof Areas Roof Surface Material: Asphalt shingle There are ridge cap shingles missing from this roof.
At the intersection the rear units walls, there is an area about 6'X6' where the plywood sheathing is very soft and dangerous to walk upon.

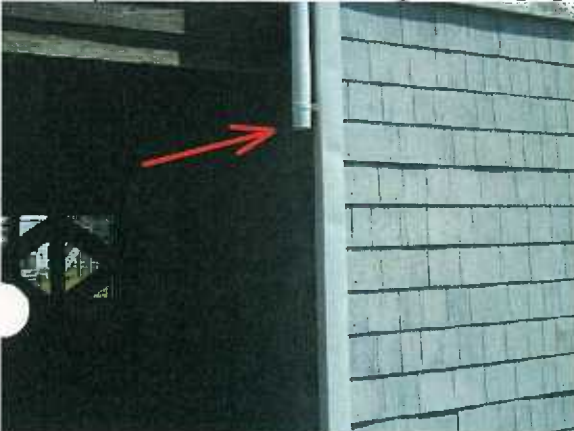
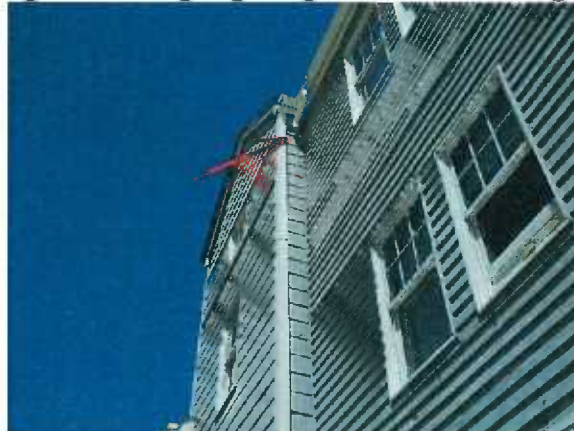
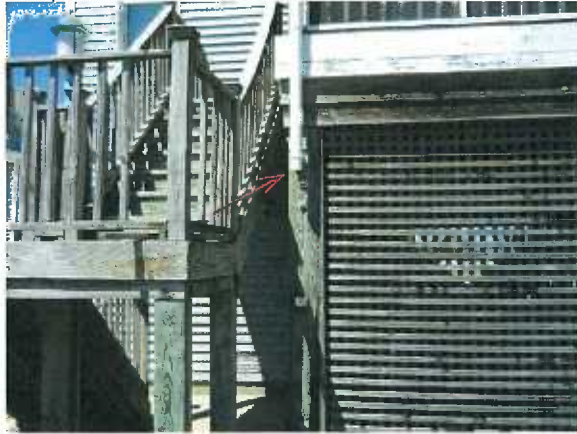
9. Downspouts: Plastic The gutter piping is not properly connected together.

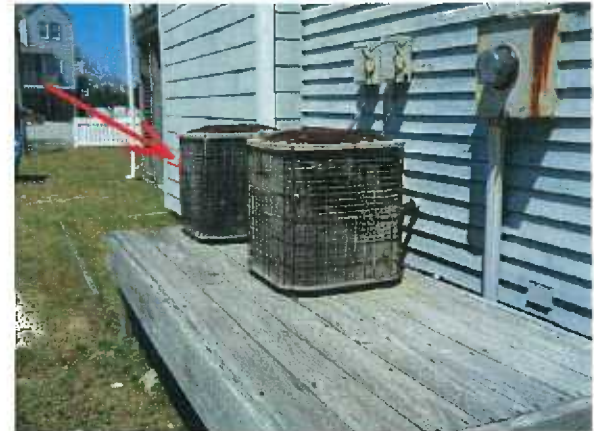
11. South Side AC System Visible Coil: Copper core with aluminum fins The aluminum fins surrounding the copper coil are becoming deteriorated and falling away from the copper coil. The aluminum fins are present to dissipate the heat from the copper coil and when the fins are no longer present the coil will over heat and the condenser will cease to function.

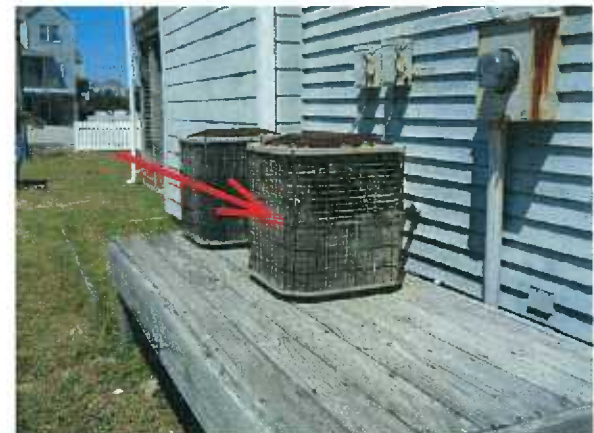
14. South Side AC System Visible Coil: Copper core with aluminum fins The aluminum fins surrounding the copper coil are becoming deteriorated and falling away from the copper coil. The aluminum fins are present to dissipate the heat from the copper coil and when the fins are no longer present the coil will over heat and the condenser will cease to function.

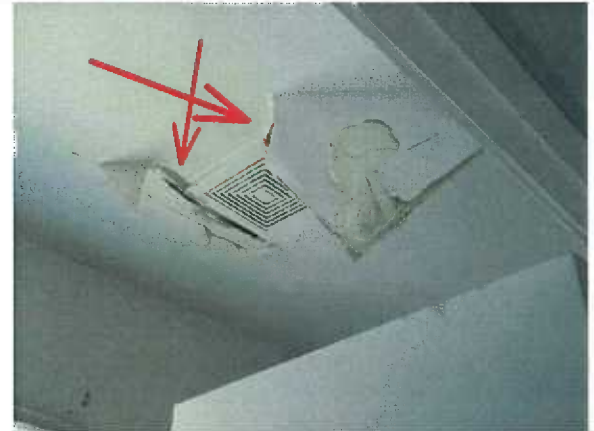
16. Main Level Powder Room Bathroom Ceiling: Drywall There is a large hole in the drywall ceiling.

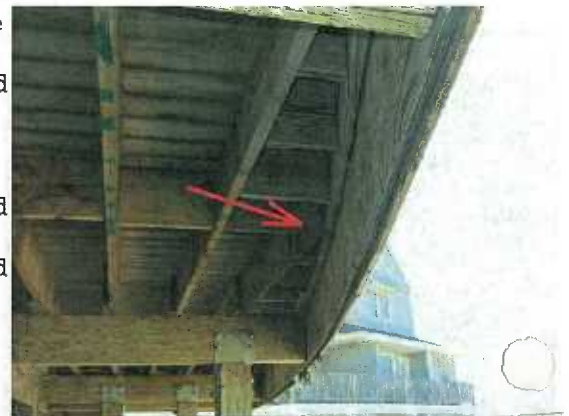
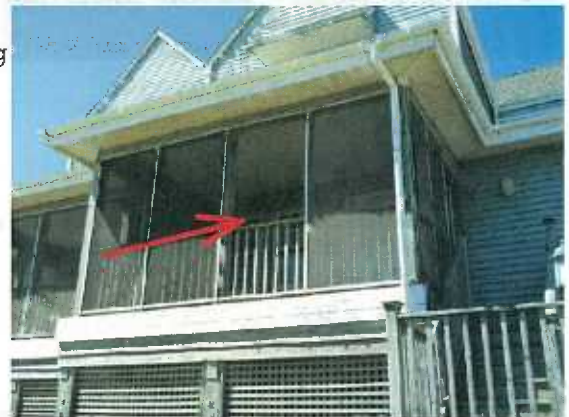
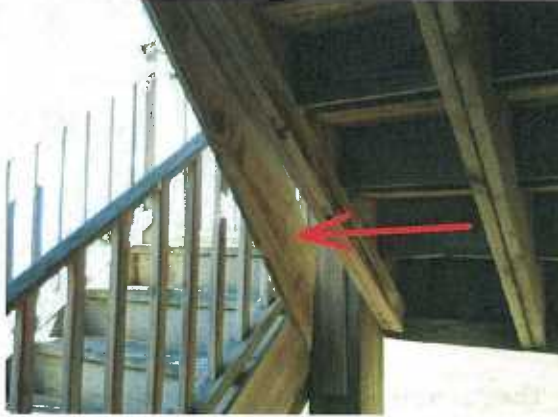
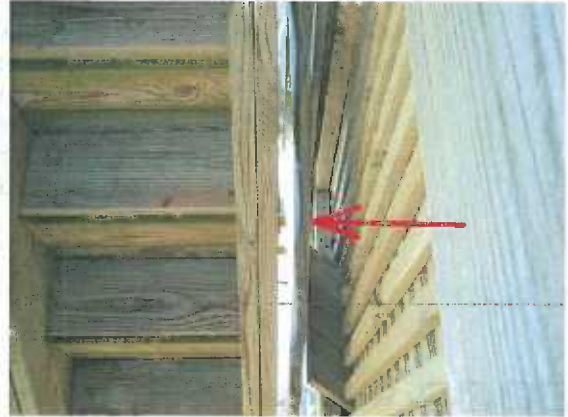
| 6. | <input type="checkbox"/> | <input type="checkbox"/> | <input type="checkbox"/> | <input type="checkbox"/> | <input type="checkbox"/> | <input checked="" type="checkbox"/> | Stairs/Landing: Rear Stairs & Landing, Pressure Treated Wood The decorative wood trim at the top of the handrail post, most of this trim is missing or deteriorated. The wood pickets are loose or out of place. The nails used to secure the pickets are rusty/deteriorated. |

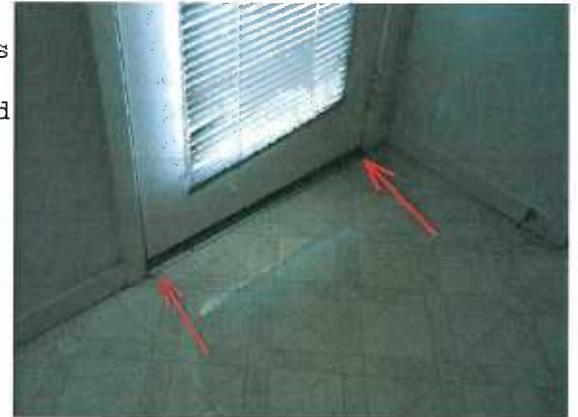
8. ☐ ☐ ☐ ☒ ☐ Type: Plywood Panels with machine shake appearance. The exterior of the house should be pressure washed and repainted.
9. ☒ ☐ ☐ ☐ ☐ Trim: Wood, Aluminum Covered
10. ☒ ☐ ☐ ☐ ☐ Fascia: Wood, wrapped with Aluminum Coil Stock
11. ☒ ☐ ☐ ☐ ☐ Soffits: Vinyl panels
12. ☒ ☐ ☐ ☐ ☐ Entry Doors: Ground Front, Fiberglass, Full View Glass
13. ☒ ☐ ☐ ☐ ☐ Entry Door: Ground Utility Room, Fiberglass, Flush Solid Core
14. ☒ ☐ ☐ ☐ ☐ Entry Door: Main Living Area, Fiberglass, Full View Glass
15. ☐ ☐ ☐ ☐ ☒ Entry Door: Kitchen/Dining Area, Fiberglass, Full view Glass Moisture is migrating to the inside at the door threshold. The door and threshold need to be adjusted to stop the moisture migration.

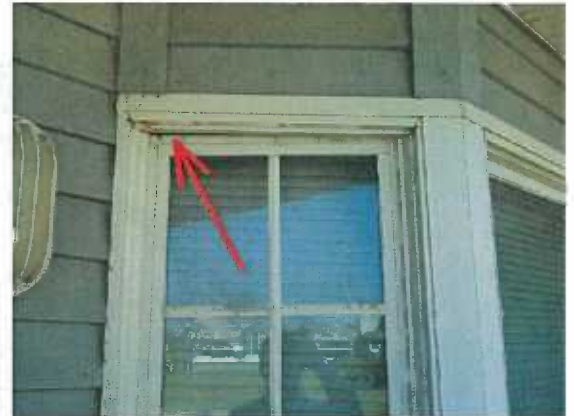
16. ☒ ☐ ☐ ☐ ☐ Windows: Andersen Double Hung, Tilt & Wash Feature The bay window in the kitchen eating area, the outer edge of this window unit is bowing down, causing the openings for the double hung windows on the sides to be out of square, keeping the double hung window from being closed properly.

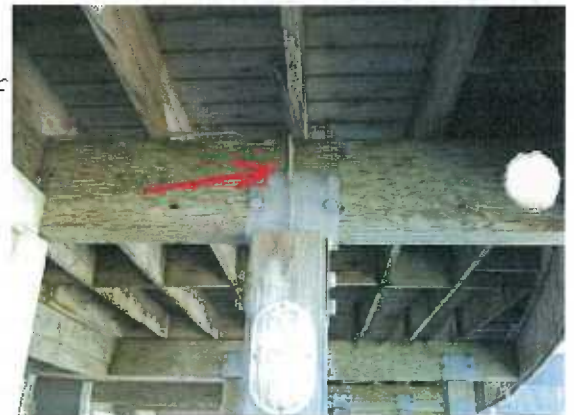
18. ☐ ☐ ☐ ☐ ☒ Exterior Lighting: Exterior, Surface Mount There is a exterior light under the front deck that was wired with interior romex wiring that should have been installed in electrical conduit. There is a light installed for the rear stairs. The interior romex wiring for this light should have been installed in electrical conduit.

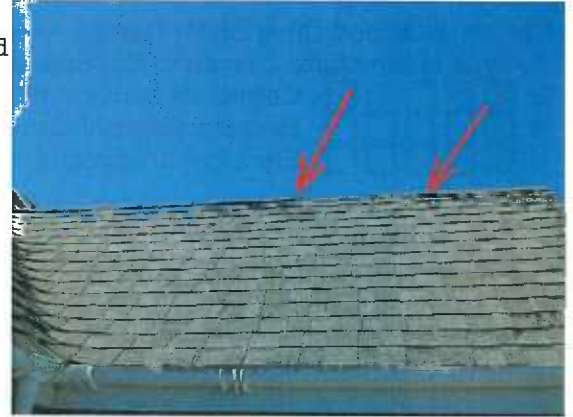
2. ☐ ☐ ☐ ☐ ☒ Material: Asphalt shingle There are ridge cap shingles missing from the ridge and there is a patch of shingle missing from the roof.

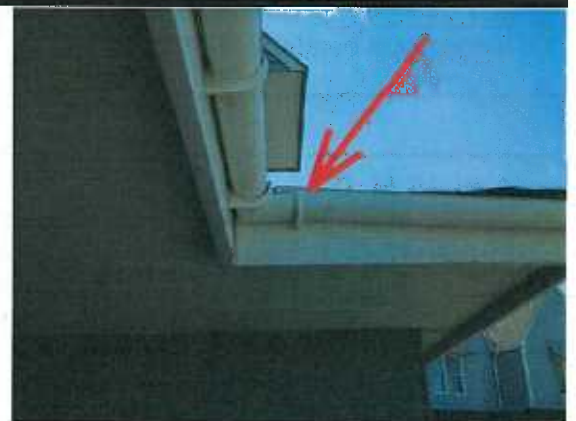
10. ☐ ☐ ☐ ☐ ☒ Gutters: Plastic Parts of the gutters and down spouts are missing or damaged on most units.

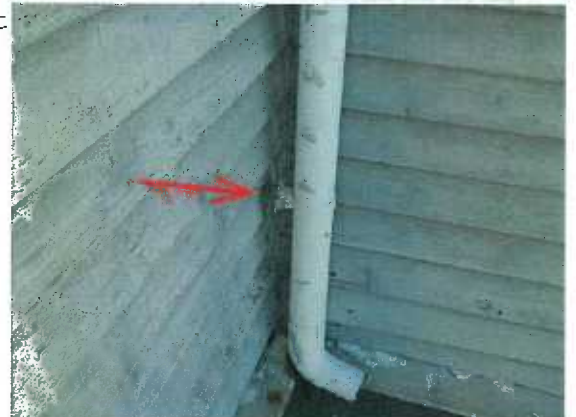
11. ☐ ☐ ☐ ☐ ☒ Downspouts: Plastic The gutter down spout has become disconnected.

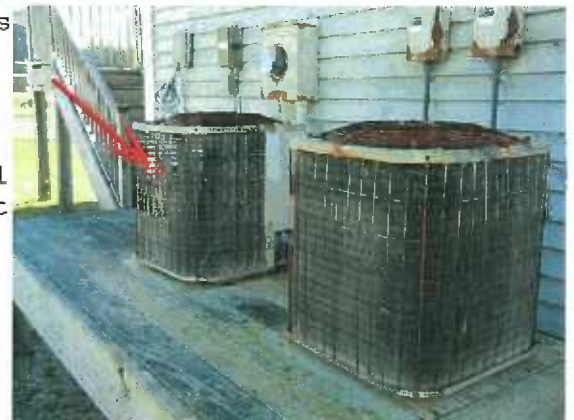
1. ☐ ☐ ☐ ☐ ☒ A/C System Operation: Inoperative The unit is currently in service beyond the manufactures stated design life
2. ☒ ☐ ☐ ☐ ☐ Condensate Removal: Plastic tubing
3. ☒ ☐ ☐ ☐ ☐ Exterior Unit: Mounted on wooden platform
4. Manufacturer: Carrier
5. Area Served: Ground & Mid Levels Approximate Age: 14 to 16 years
6. Fuel Type: Electric Temperature Differential: x
7. Type: Heat pump Capacity: 2 ton
8. ☐ ☐ ☐ ☐ ☒ Visible Coil: Copper core with aluminum fins
The aluminum fins surrounding the copper coil are becoming deteriorated and falling away from the copper coil. The aluminum fins are present to dissipate the heat from the copper coil and when the fins are no longer present the coil will over heat and the condenser will cease to function.
9. ☐ ☐ ☐ ☐ ☒ Refrigerant Lines: Rubbertex Insulation The black rubbertex insulation on the copper tubing is deteriorated and should be replaced.

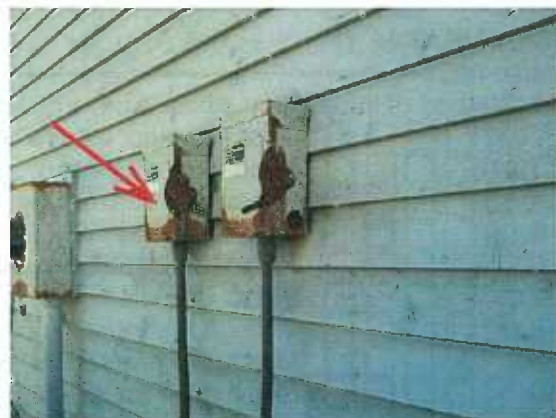
10. ☐ ☐ ☐ ☒ ☐ Electrical Disconnect: Tumble switch The HVAC electric disconnect box is very rusty.

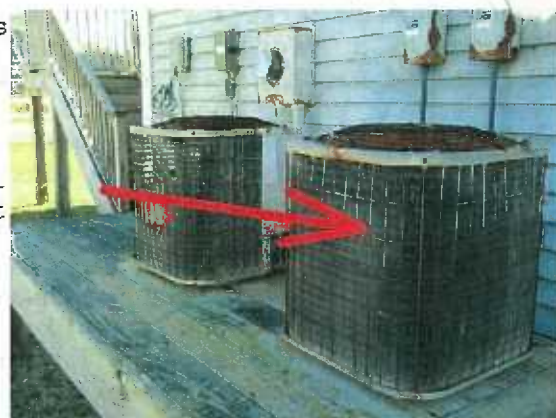
11. ☐ ☐ ☐ ☒ A/C System Operation: Inoperative The unit is currently in service beyond the manufactures stated design life
12. ☒ ☐ ☐ ☐ Condensate Removal: Plastic tubing
13. ☒ ☐ ☐ ☐ Exterior Unit: Mounted on wooden platform
14. Manufacturer: Carrier
15. Area Served: Top Floor Approximate Age: 12 to 14 years
16. Fuel Type: Electric Temperature Differential: x
17. Type: Heat pump Capacity: 1.5 ton
18. ☐ ☐ ☐ ☒ Visible Coil: Copper core with aluminum fins The aluminum fins surrounding the copper coil are becoming deteriorated and falling away from the copper coil. The aluminum fins are present to dissipate the heat from the copper coil and when the fins are no longer present the coil will over heat and the condenser will cease to function.

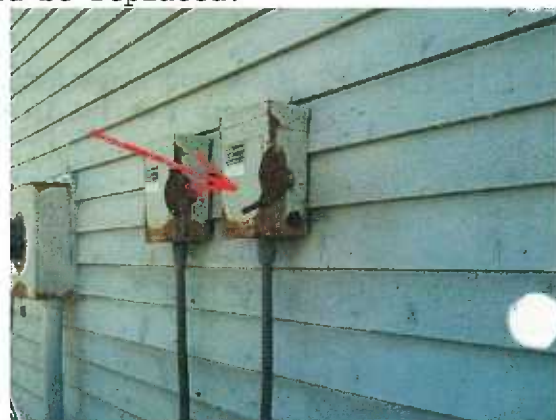
19. ☐ ☐ ☐ ☒ Refrigerant Lines: Rubbertex Insulation The black rubbertex insulation on the copper tubing is deteriorated and should be replaced.
20. ☐ ☐ ☒ ☐ Electrical Disconnect: Tumble switch The HVAC electric disconnect box is very rusty.

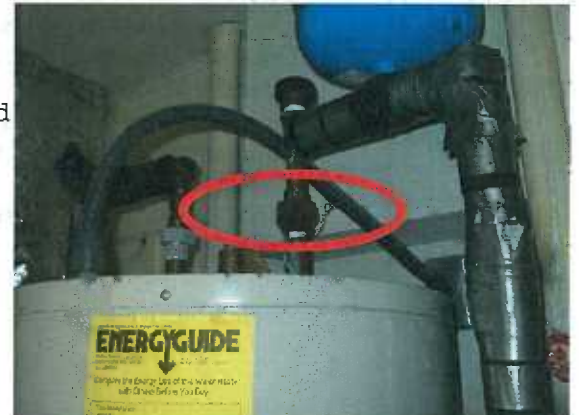
6. ☐ ☐ ☒ ☐ ☐ Water Heater Operation: Water turned off at time of inspection. One of the unions connecting the water heater to the house plumbing is very rusty and should be replaced.

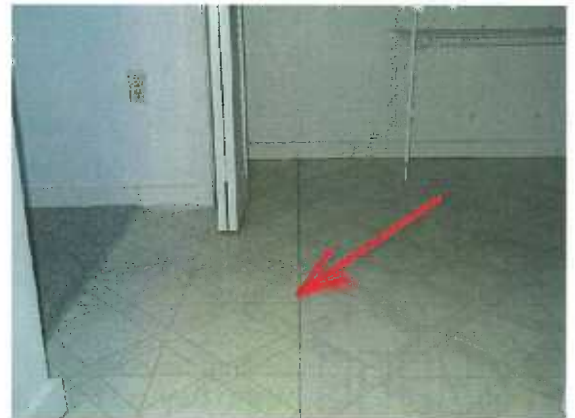
10. ☒ ☐ ☐ ☐ ☐ Ceiling: Drywall
11. ☒ ☐ ☐ ☐ ☐ Walls: Drywall
12. ☐ ☐ ☐ ☐ ☒ Floor: Vinyl floor covering The vinyl flooring is damaged at the top of the stairs.

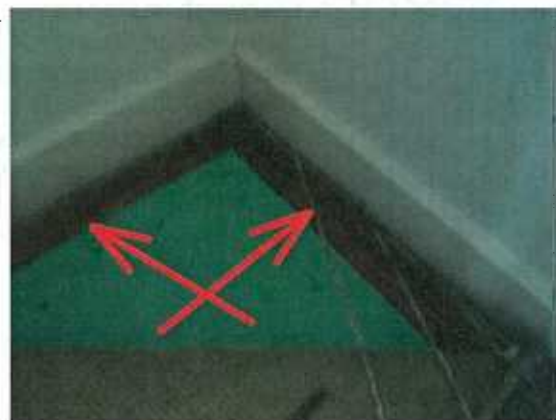
| 4. | <input type="checkbox"/> | <input type="checkbox"/> | <input type="checkbox"/> | <input type="checkbox"/> | <input checked="" type="checkbox"/> | Floor: Carpet The carpet tack strip along the unit party wall, the strip is stained and the tacks are rusty. |

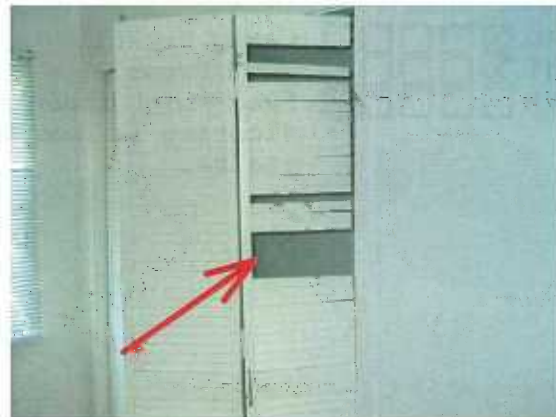
| 9. | <input type="checkbox"/> | <input type="checkbox"/> | <input type="checkbox"/> | <input type="checkbox"/> | <input checked="" type="checkbox"/> | Closet: Single Closet Door is damaged. |

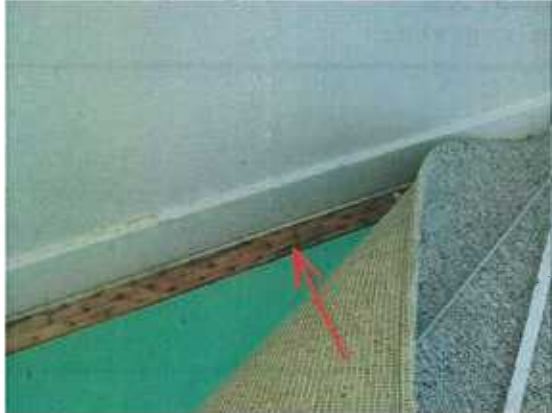
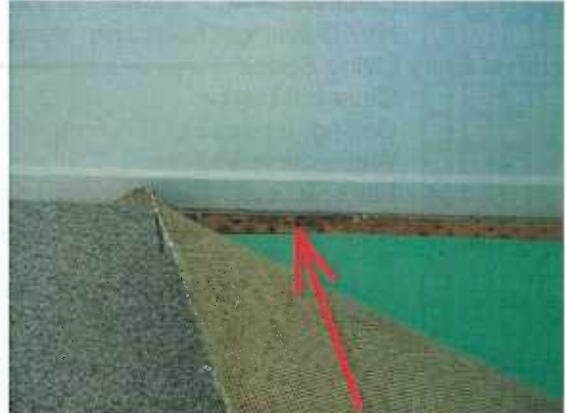
12. ☐ ☐ ☐ ☐ ☒ Floor: Carpet There is a stain on the carpet. The carpet tack strip along the unit party wall, the strip is stained and the tacks are rusty.

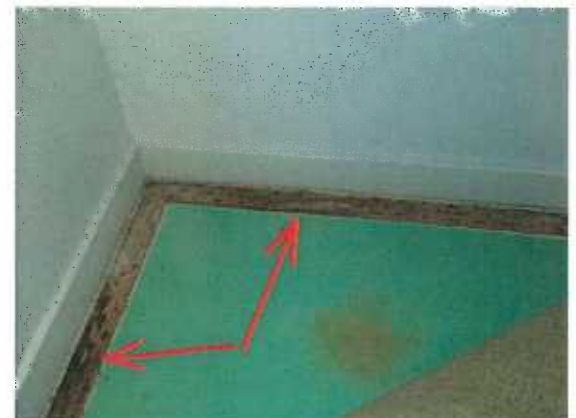
7. ☒ ☐ ☐ ☐ ☐ Closet: Single
 8. ☐ ☐ ☐ ☒ ☐ Ceiling: Drywall Paint is peeling from the ceiling.
 9. ☒ ☐ ☐ ☐ ☐ Walls: Drywall
 10. ☐ ☐ ☐ ☐ ☒ Floor: Carpet The carpet is stained. The carpet tack strip along the unit party wall, the strip is stained and the tacks are rusty.

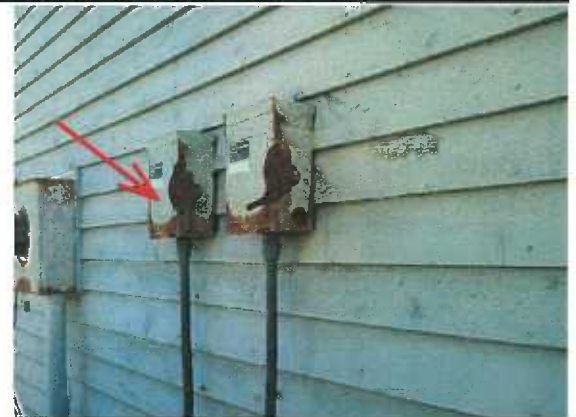
4. **North Side AC System Electrical Disconnect:** Tumble switch The HVAC electric disconnect box is very rusty.

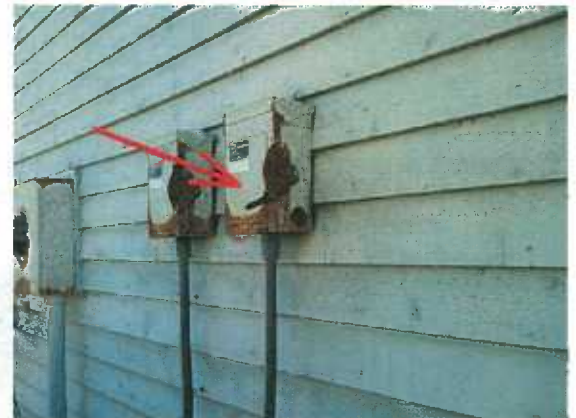
5. **North Side AC System Electrical Disconnect:** Tumble switch The HVAC electric disconnect box is very rusty.

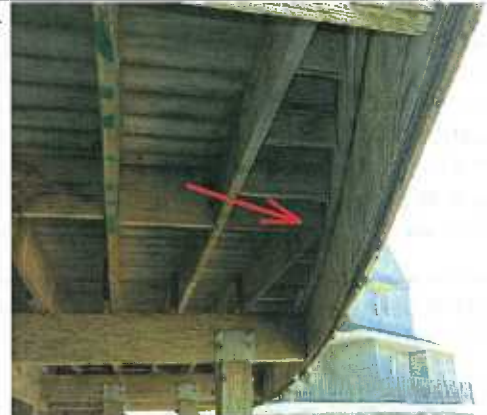
1. Deck: Front, Pressure Treated Wood There is one floor joist near the front of the deck that is not properly supported with a metal joist hanger. Several of the handrail pickets are loose and out of place. Close inspection revealed that the nails used to fasten the pickets to the top and bottom rails are rusty and deteriorated and failing to perform their intended function.

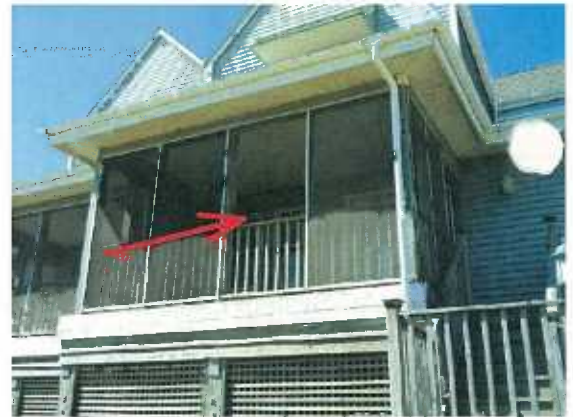
2. Porch: Rear Porch, Pressure Treated Wood Screen panels for the porch are missing or damaged. The porch screen door is damaged.

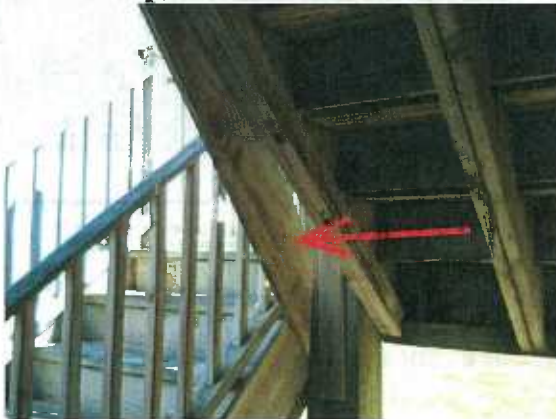
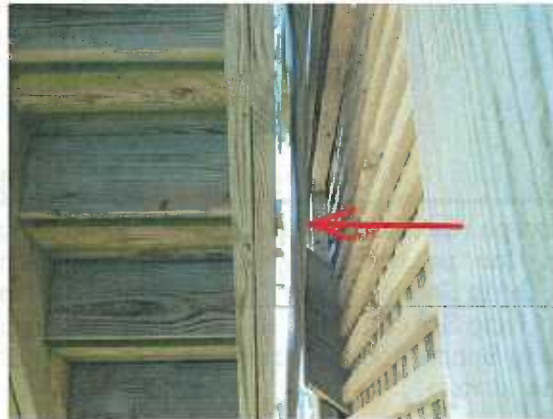
3. Stairs/Landing: Rear Stairs & Landing, Pressure Treated Wood The decorative wood trim at the top of the handrail post, most of this trim is missing or deteriorated. The wood pickets are loose or out of place. The nails used to secure the pickets are rusty/deteriorated.

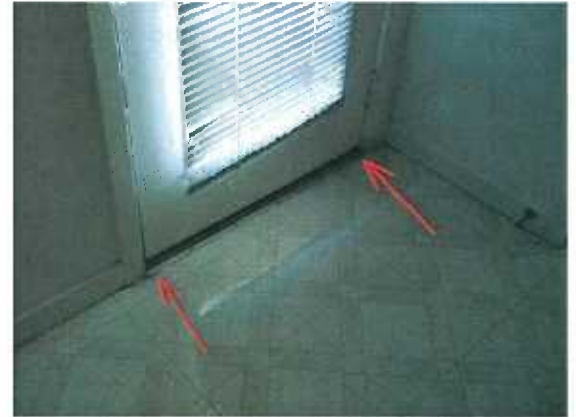
4. Entry Door: Kitchen/Dining Area, Fiberglass, Full view Glass Moisture is migrating to the inside at the door threshold. The door and threshold need to be adjusted to stop the moisture migration.

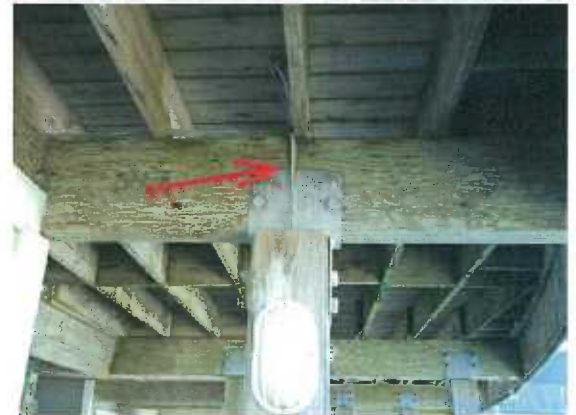
5. Exterior Lighting: Exterior, Surface Mount There is a exterior light under the front deck that was wired with interior romex wiring that should have been installed in electrical conduit. There is a light installed for the rear stairs. The interior romex wiring for this light should have been installed in electrical conduit.

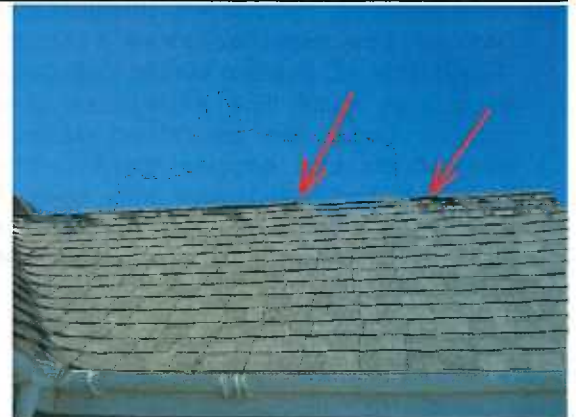
6. All Roof Areas Roof Surface Material: Asphalt shingle There are ridge cap shingles missing from the ridge and there is a patch of shingle missing from the roof.

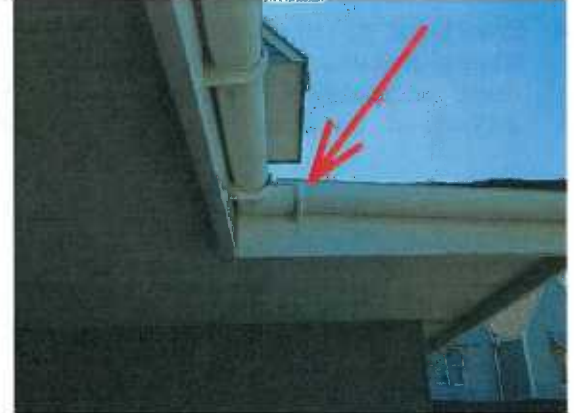
8. Gutters: Plastic Parts of the gutters and down spouts are missing or damaged on most units.

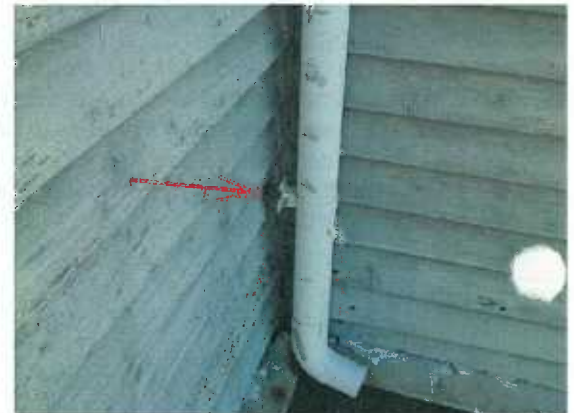
9. Downspouts: Plastic The gutter down spout has become disconnected.

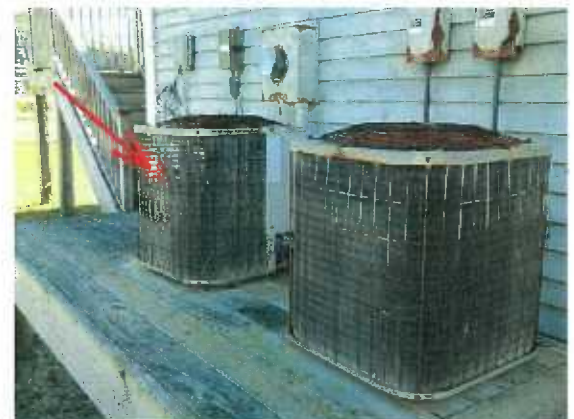
10. North Side AC System A/C System Operation: Inoperative The unit is currently in service beyond the manufactures stated design life
11. North Side AC System Visible Coil: Copper core with aluminum fins The aluminum fins surrounding the copper coil are becoming deteriorated and falling away from the copper coil. The aluminum fins are present to dissipate the heat from the copper coil and when the fins are no longer present the coil will over heat and the condenser will cease to function.

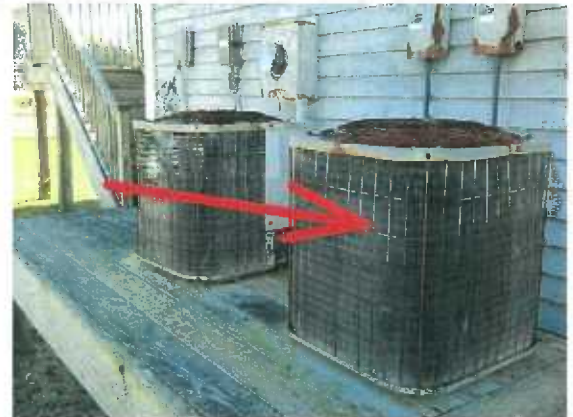
14. North Side AC System Visible Coil: Copper core with aluminum fins The aluminum fins surrounding the copper coil are becoming deteriorated and falling away from the copper coil. The aluminum fins are present to dissipate the heat from the copper coil and when the fins are no longer present the coil will over heat and the condenser will cease to function.

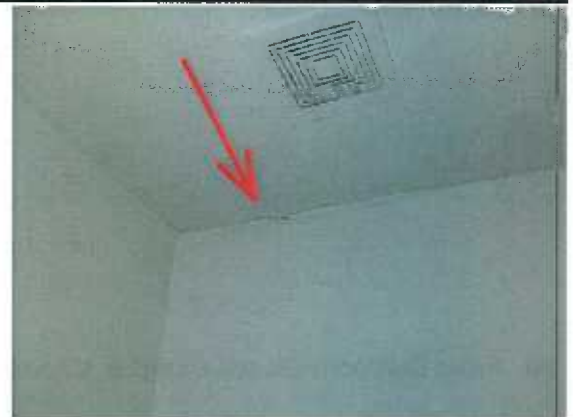
16. Mail Level Powder Room Bathroom Ceiling: Drywall The drywall is damaged along the edge where the ceiling and wall intersect.

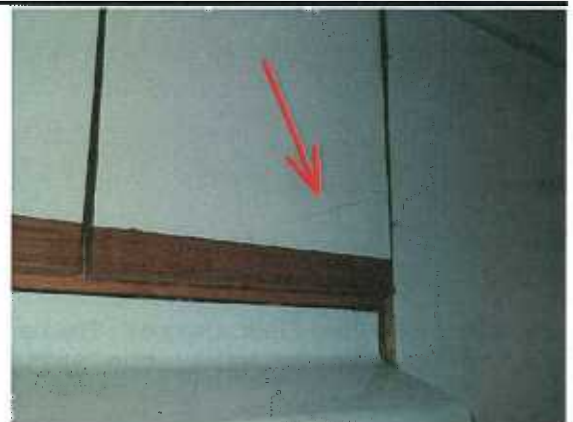
17. Kitchen & Dining Area, Main Level Kitchen Cabinets: Flush Laminate The cabinet doors need to be adjusted. The cabinet above the range is damaged.

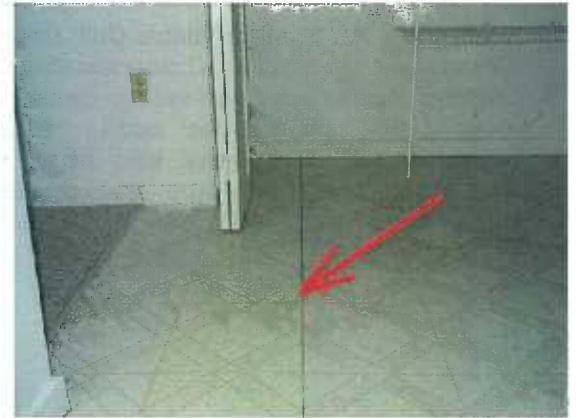
18. Kitchen & Dining Area, Main Level Kitchen Floor: Vinyl floor covering The vinyl flooring is damaged at the top of the stairs.

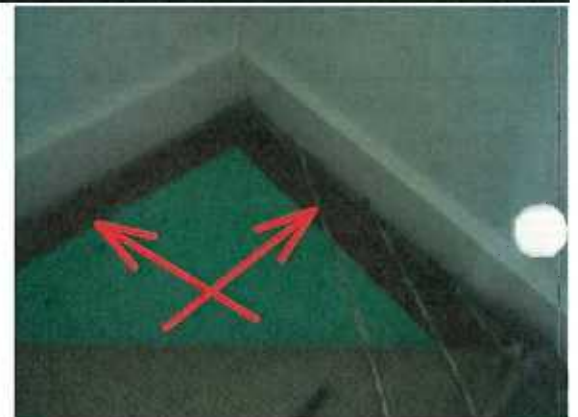
19. Rear Bedroom Floor: Carpet The carpet tack strip along the unit party wall, the strip is stained and the tacks are rusty.

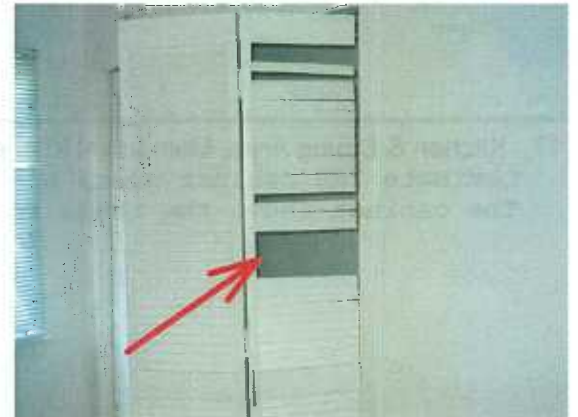
20. Front Bedroom Closet: Single Closet Door is damaged.

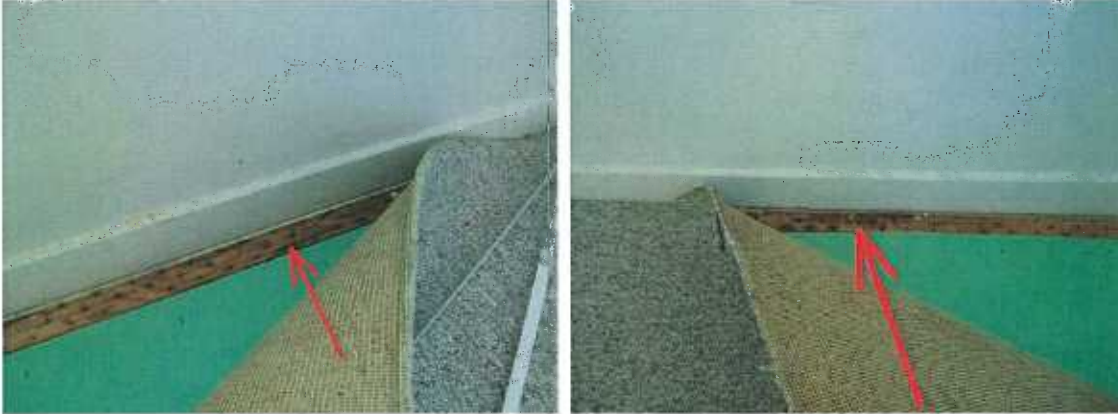
21. Front Bedroom Floor: Carpet There is a stain on the carpet. The carpet tack strip along the unit party wall, the strip is stained and the tacks are rusty.

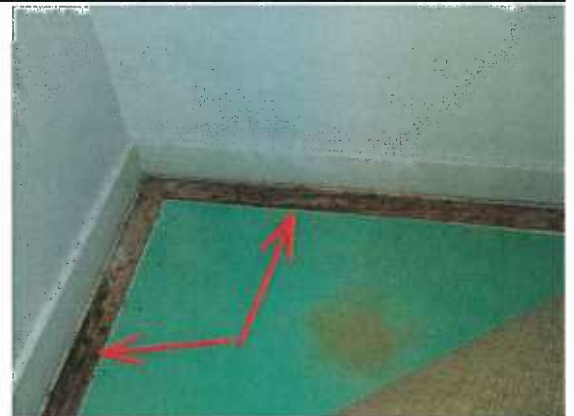
23. Main Level Living Area Living Space Floor: Carpet The carpet is stained. The carpet tack strip along the unit party wall, the strip is stained and the tacks are rusty.
